Desk Study & Risk Assessment Report

Project Name: Land at Brook Farm

Project ID: J15100

Report Date: 11th April 2022

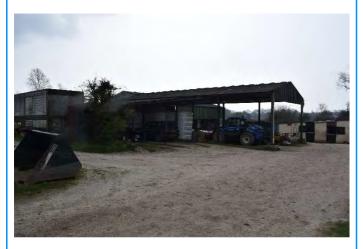
Farmyard buildings within sites SW quarter

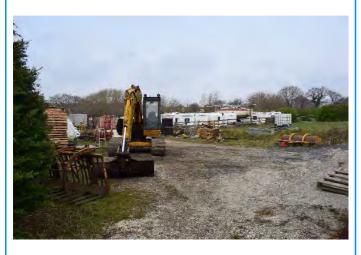
Store of caravans and machinery in sites SW quarter
