Desk Study & Risk Assessment Report

Project Name: Land at Brook Farm

Location: Daws Heath Road, Daws Heath, SS7 2UG

Project ID: J15100

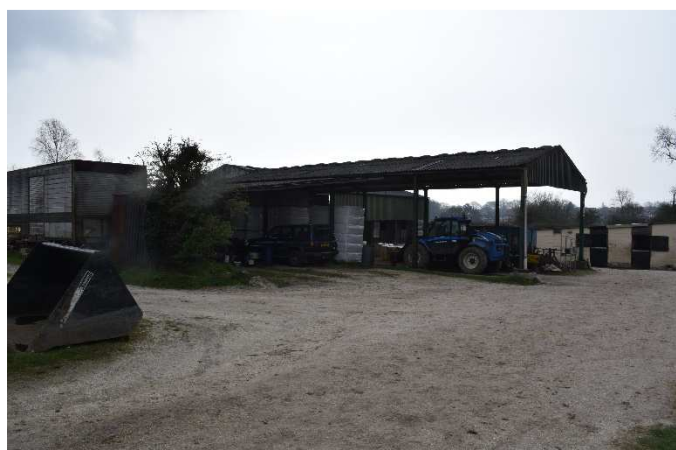
Farmyard buildings within site's SW quarter

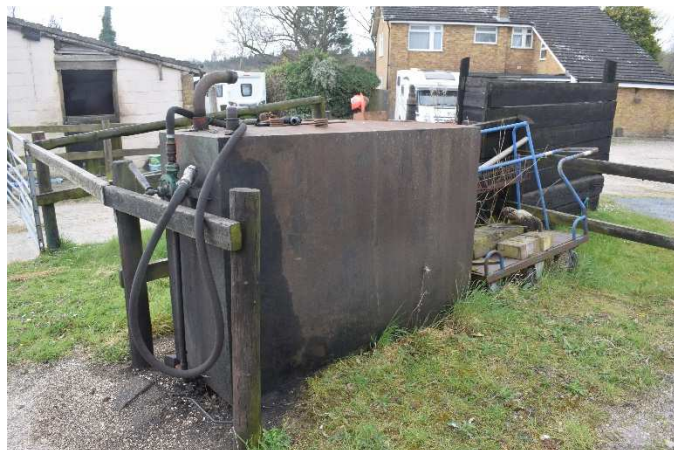
Current land usage in the south western quarter of the site for the stabling of horses and the storage of caravans/motorhomes may also present a potential contaminant source. During the walkover survey a single external metal fuel tank was observed in this area, with some farm machinery housed within the barn structures which were noted to be roofed with possible corrugated asbestos cement.

Fuel tank within site's SW quarter

It is advised that any intrusive investigation, in addition to providing general site coverage, should target soils around the existing buildings in the south western quarter of the site, including adjacent to an existing fuel tank.

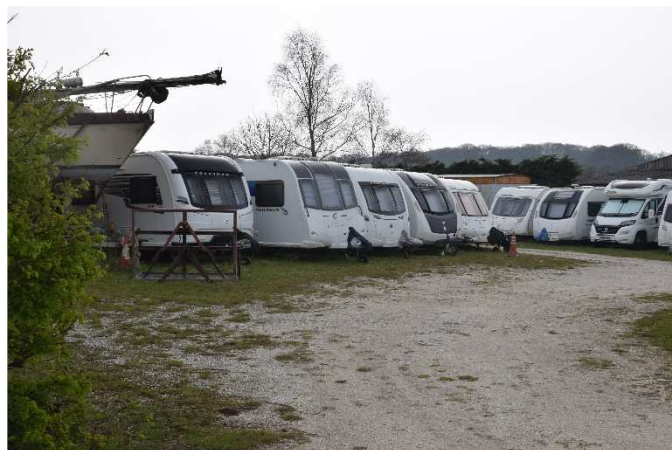
Caravan storage within site's SW quarter

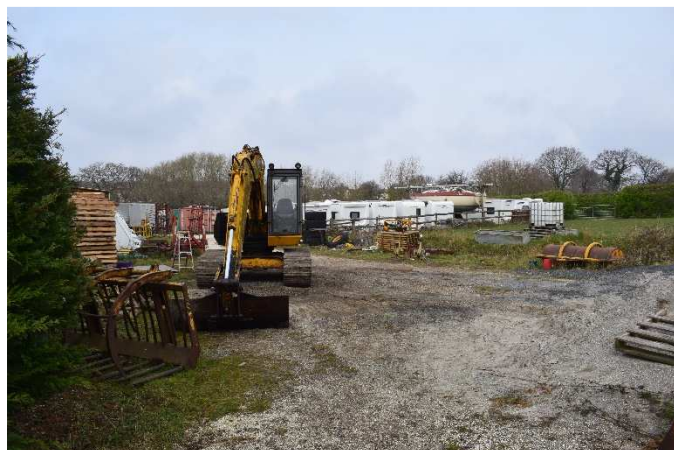
Store of caravans and machinery in site's SW quarter

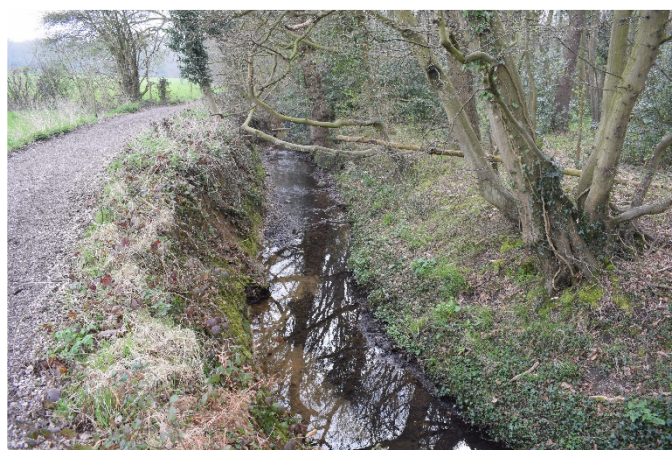
View of Prittle Brook adj to site's SE boundary

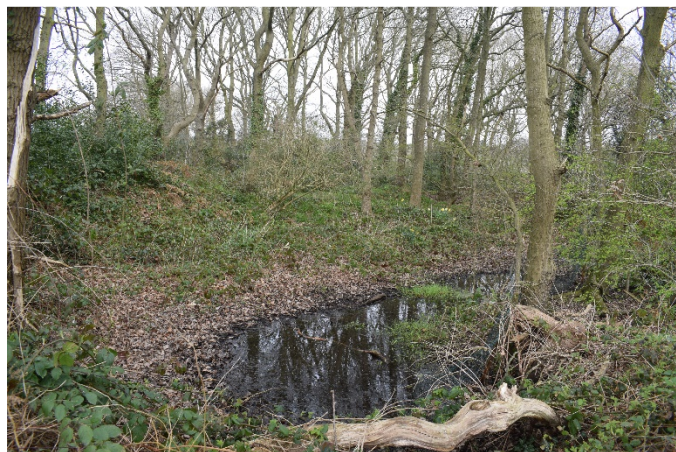
During the walkover survey, ground workings and shallow excavations (est. 1-2m deep) were observed in the location of the former gravel pit as indicated on historical mapping and within the environmental database. Published geology for this area indicates a superficial covering of glaciofluvial deposits, which nearby borehole records (Section 6.2) indicate to comprise 'flints and reworked tertiary gravels' and to have a thickness of around 1-2m. These observed excavations may therefore still represent the total extent and depth of these workings. It is therefore considered unlikely that the gravel pit was even partially infilled and subsequently can be dismissed as a potential contaminant source.

View NE of excavations within area of former gravel pit
